# Manhole Inspection Summary

Manhole # S45G\_\_012MH

Insp Date: **7/15/08 2:14 PM**

**Location** Address: **s washington st**

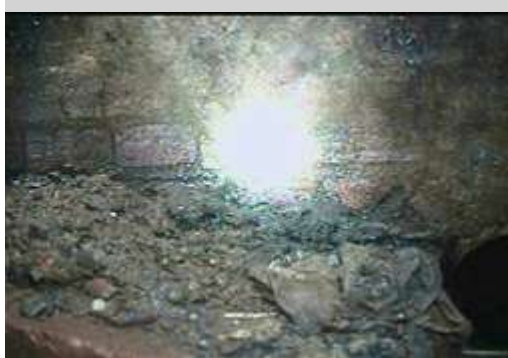
Condition: ☐ Sound ☒ **Cracked** ☐ Root Intrusion ☐ Loose Brick ☐ Deteriorated

Chimney cracked  
frame adj

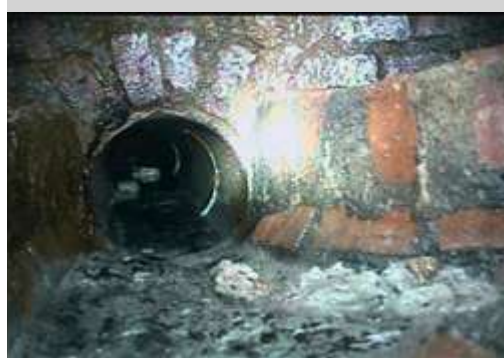
Defect 5

Condition: ☐ Sound ☐ Cracked ☐ Root Intrusion ☐ Deteriorated ☐ Leaks ☒ **Debris**

bench debris

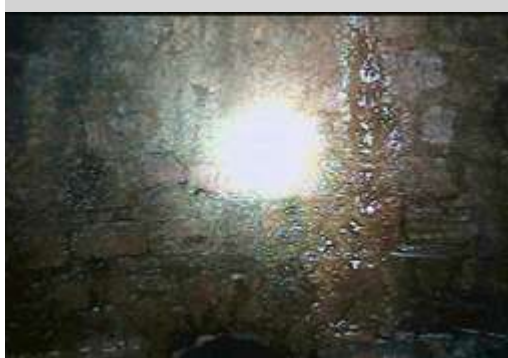
Defect 4

channel debris

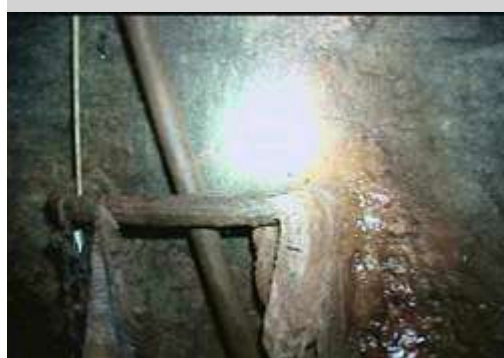
Defect 3

Infiltration: ☐ None ☐ Joint ☐ Cracks ☐ Mortar ☐ Roots ☒ **Wall**

barrell infiltration from wall

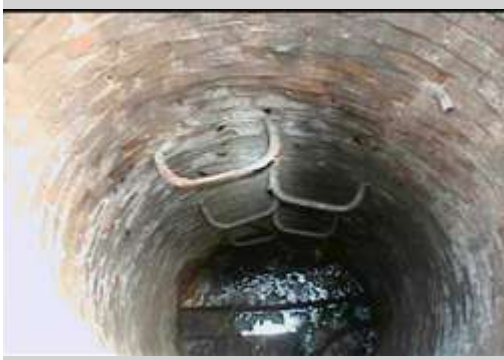
Defect 2

☒ **Evidence Of Surcharge** Depth: **10.** (ft.) ☐ Active Surcharge Present

surcharge evd.

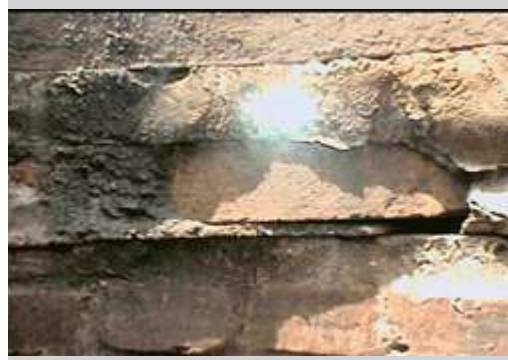
Defect 1

Count: **8** Missing: **2** ☒ **Corroded**

missing/corroded steps

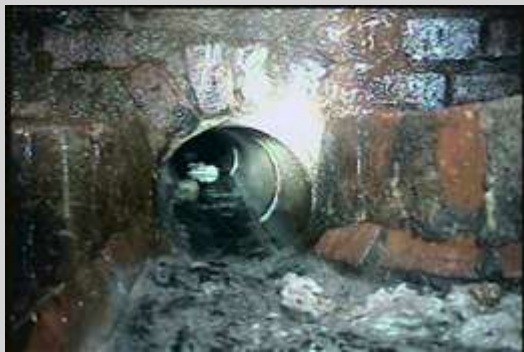
12 O'Clock Outflow

Deposits: ☐ None ☐ Mud ☐ Sludge ☒ **Debris** ☐ Grease

Silt Depth: 2 (in.) Deposits Extent: **Light**
